# Qualification of composite systems for the repair of pipelines and risers

Yves GUNALTUN, Gilles de COURTOIS  
Theo SAMOSIR  
Bernard CAVALIE

Total TDO/TEC (France)  
Total EP Indonesie  
EUPEC (France)

Indocoat 2008 - Jakarta

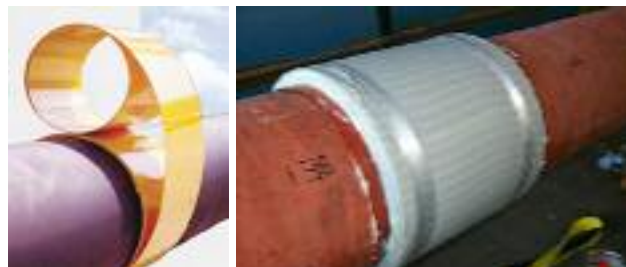
### Prefab sleeves: Clockspring

- First generation composite repair. Widely used.
- It is comprised of 8 wraps of composite, a high-strength filler material and an adhesive
- Applicable mainly on straight pipe sections

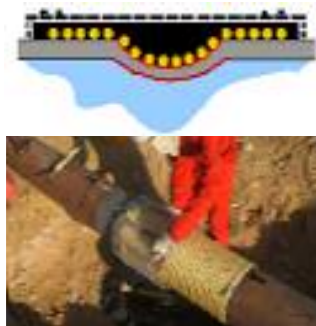
### Encapsulated systems: 3X Reinforcekit

- Wound up Kevlar rope + formwork + resin filler
- Straight pipe section only

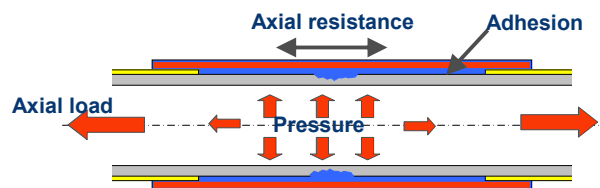
#### Some improvements are needed for unburied pipes with circumferential defects

- axial loads including end effect should be taken into account in the design by bidirectional reinforcement,
- adhesion to the steel and transmission of the load should be improved.

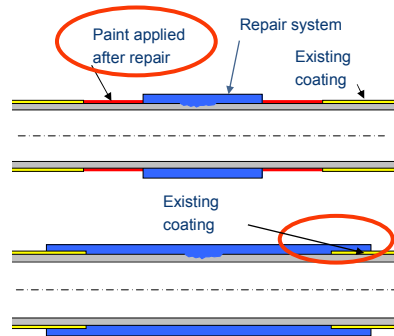
#### **Minimum requirement if no water wetting is expected**

- No overlap between the paint applied after repair
- No adhesion to the existing pipe or riser coating

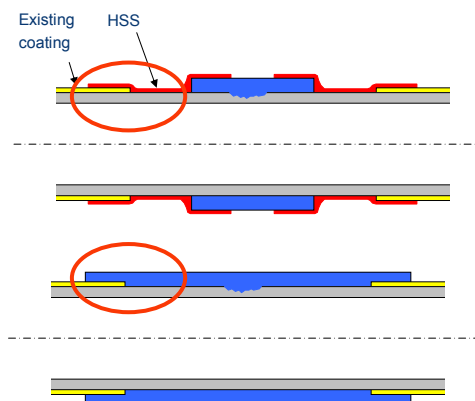
Adhesion to the existing or repair coating and painting

- No adhesion between the heat shrinkable sleeve and the pipe coating. More works are needed.
- Adhesion to the existing coating is to be improved for the immersed zone.

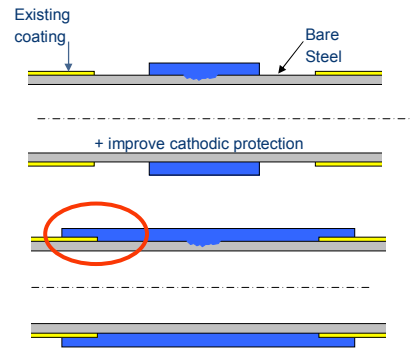
If no overlap between pipe coating and repair system, bare surface is not repaired. It is protected by cathodic protection

If overlap between repair system and pipe coating, adhesion to the pipe coating is to be improved on the overlaps or overlap area is to be removed
